NDE OF BLACK HAWK HELICOPTER ROTARY WING-HEAD SPINDLE
THREADS USING ELECTRIC CURRENT PERTURBATION

Final Report
SwRI Project 15-7958-818

U. S. Army Aviation Research and
Development Command
St. Louis, Missouri

November 1985

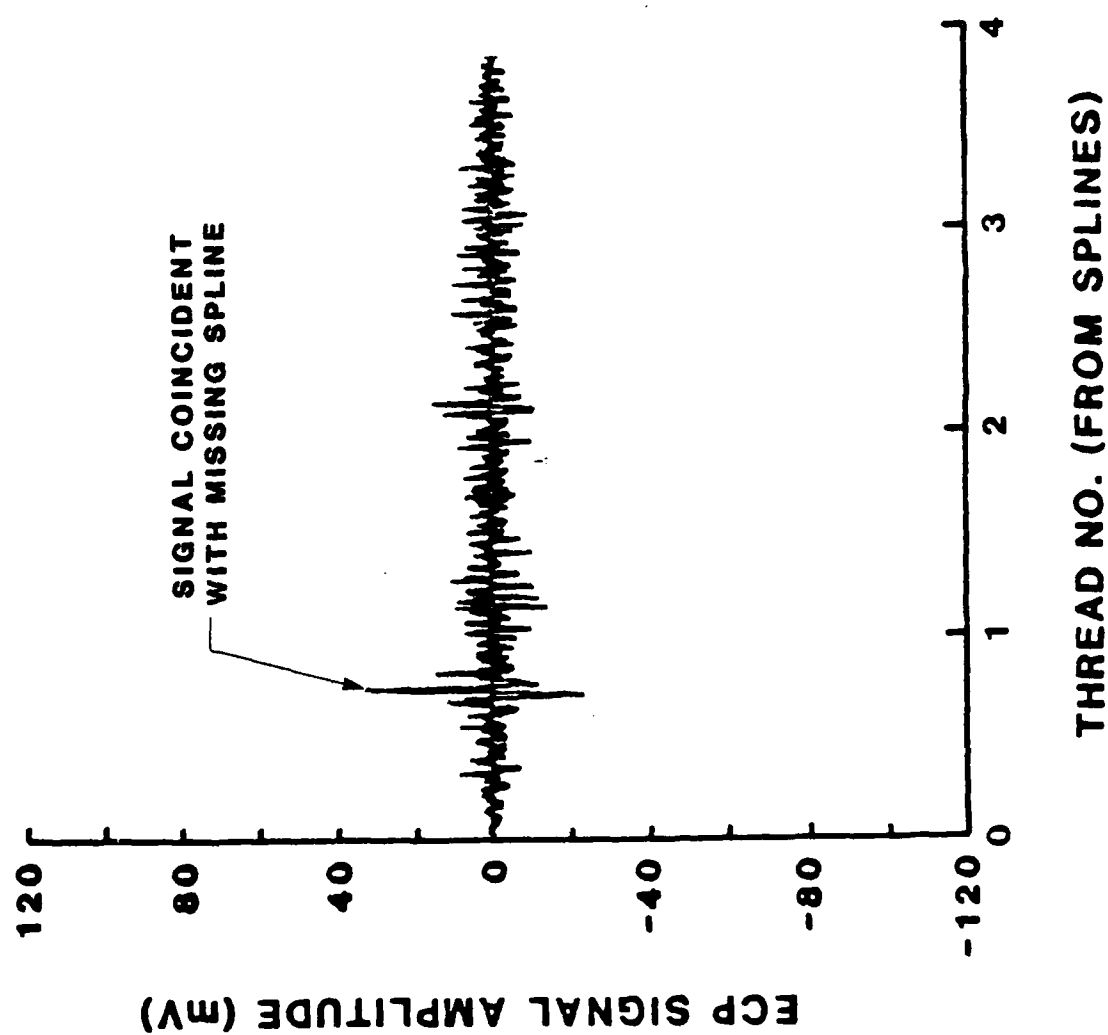
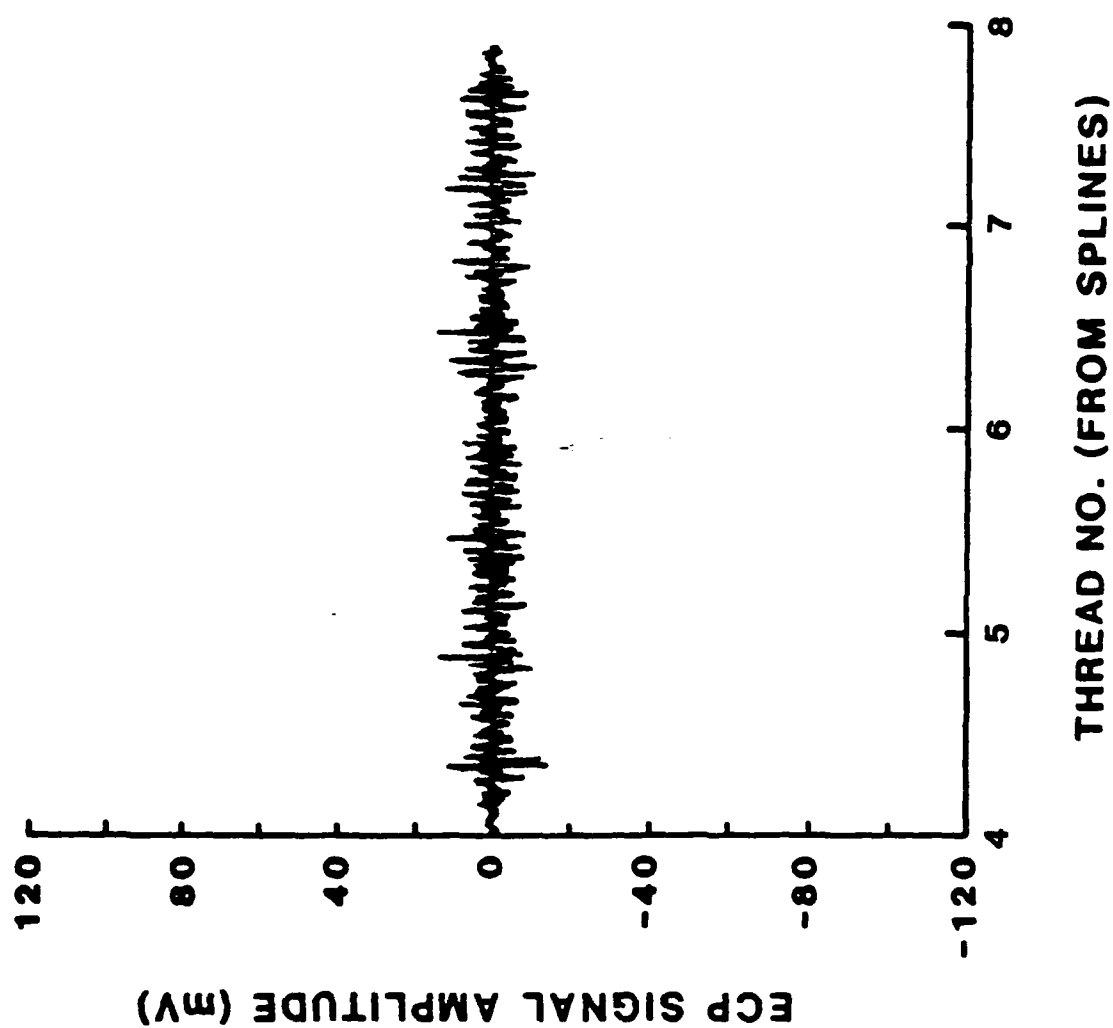
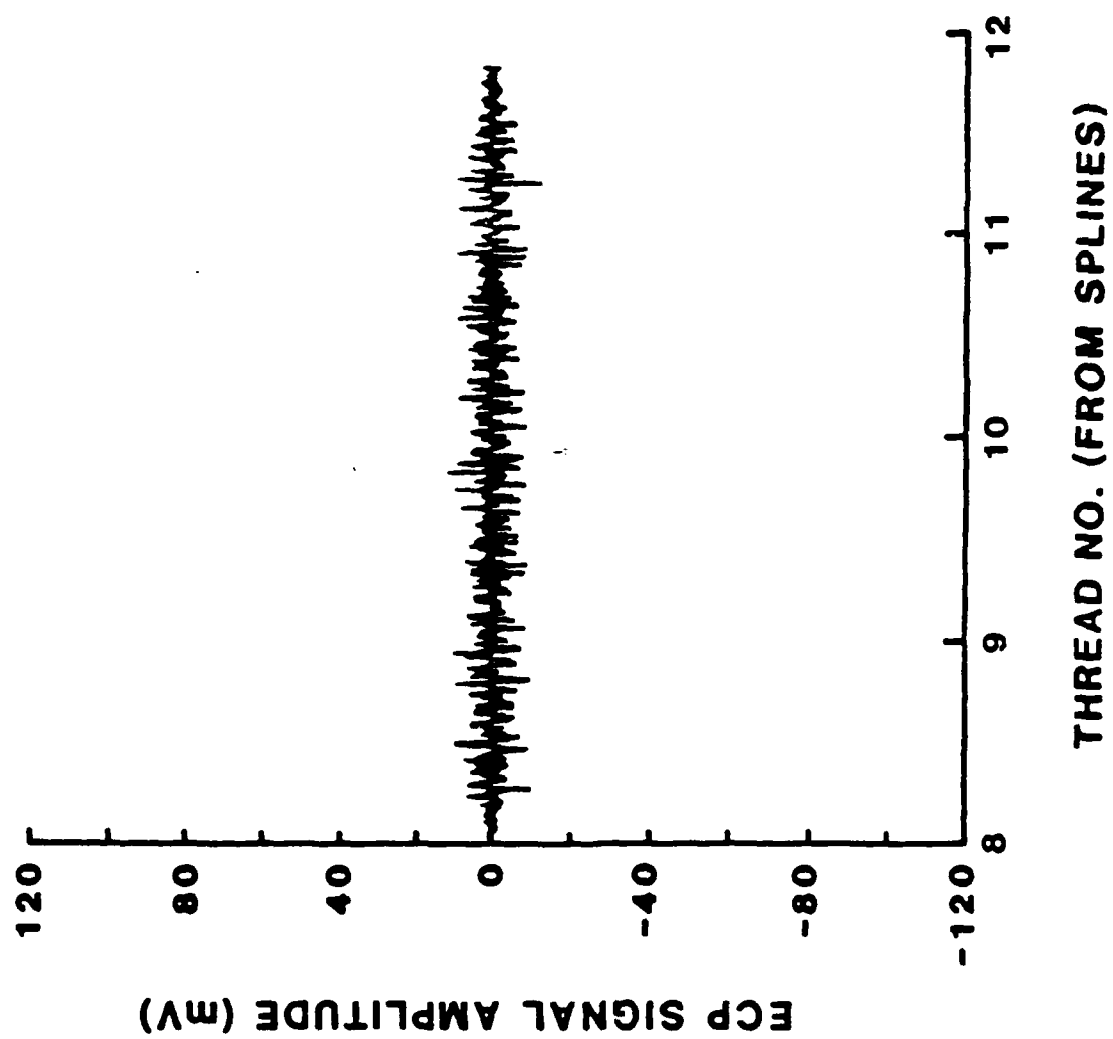
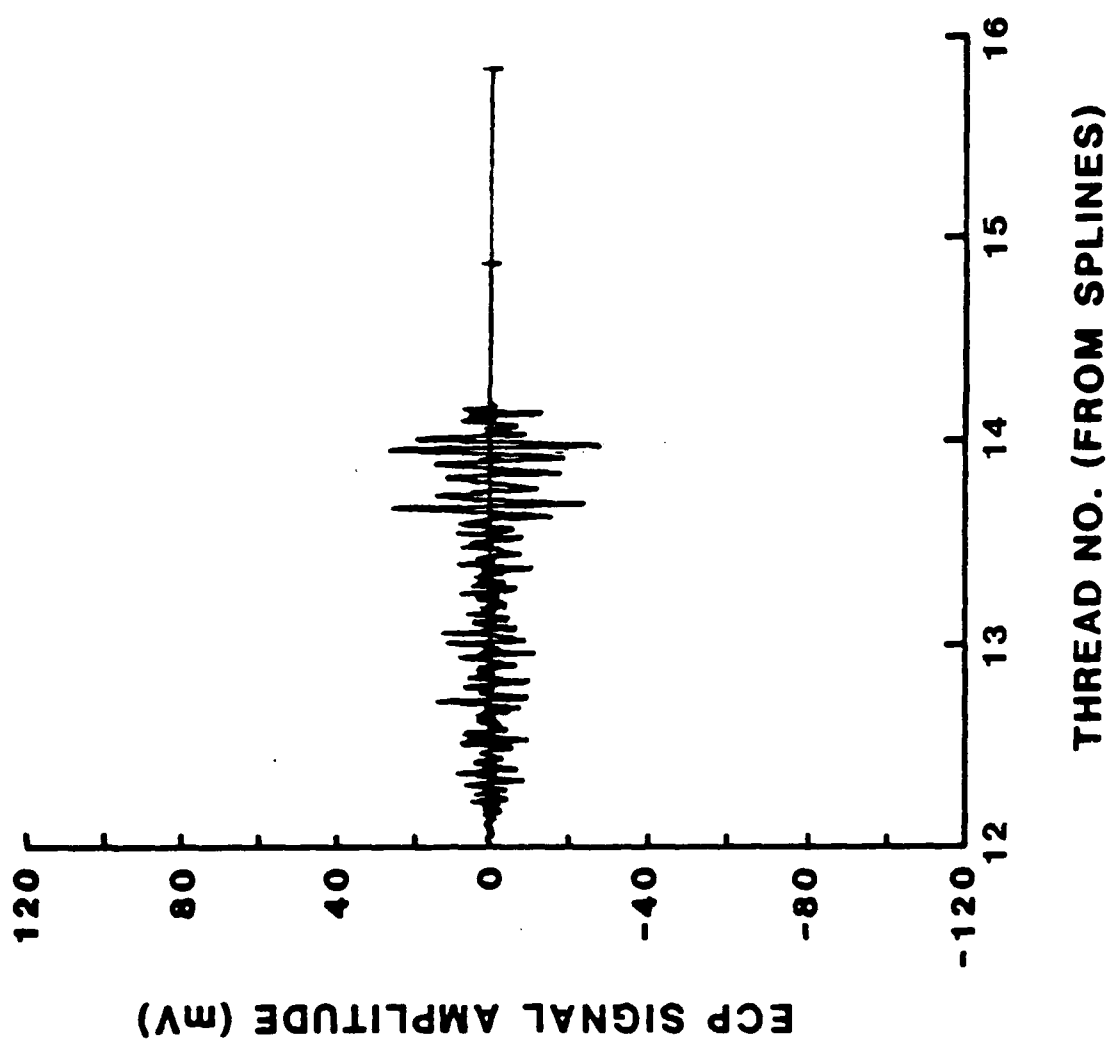
The ECP signals from specimen No. 6 are shown in Figures 19 through 22. No distinct flaw indications are evident in these data. The slightly higher background level in thread No. 13 was apparently caused by mechanical noise due to the probe holder extending beyond the end of the part.
